Middle Fork Stones River - Visual Stream Assessment

March/ April 2015 (County Farm – S Church St – 3.52 miles)

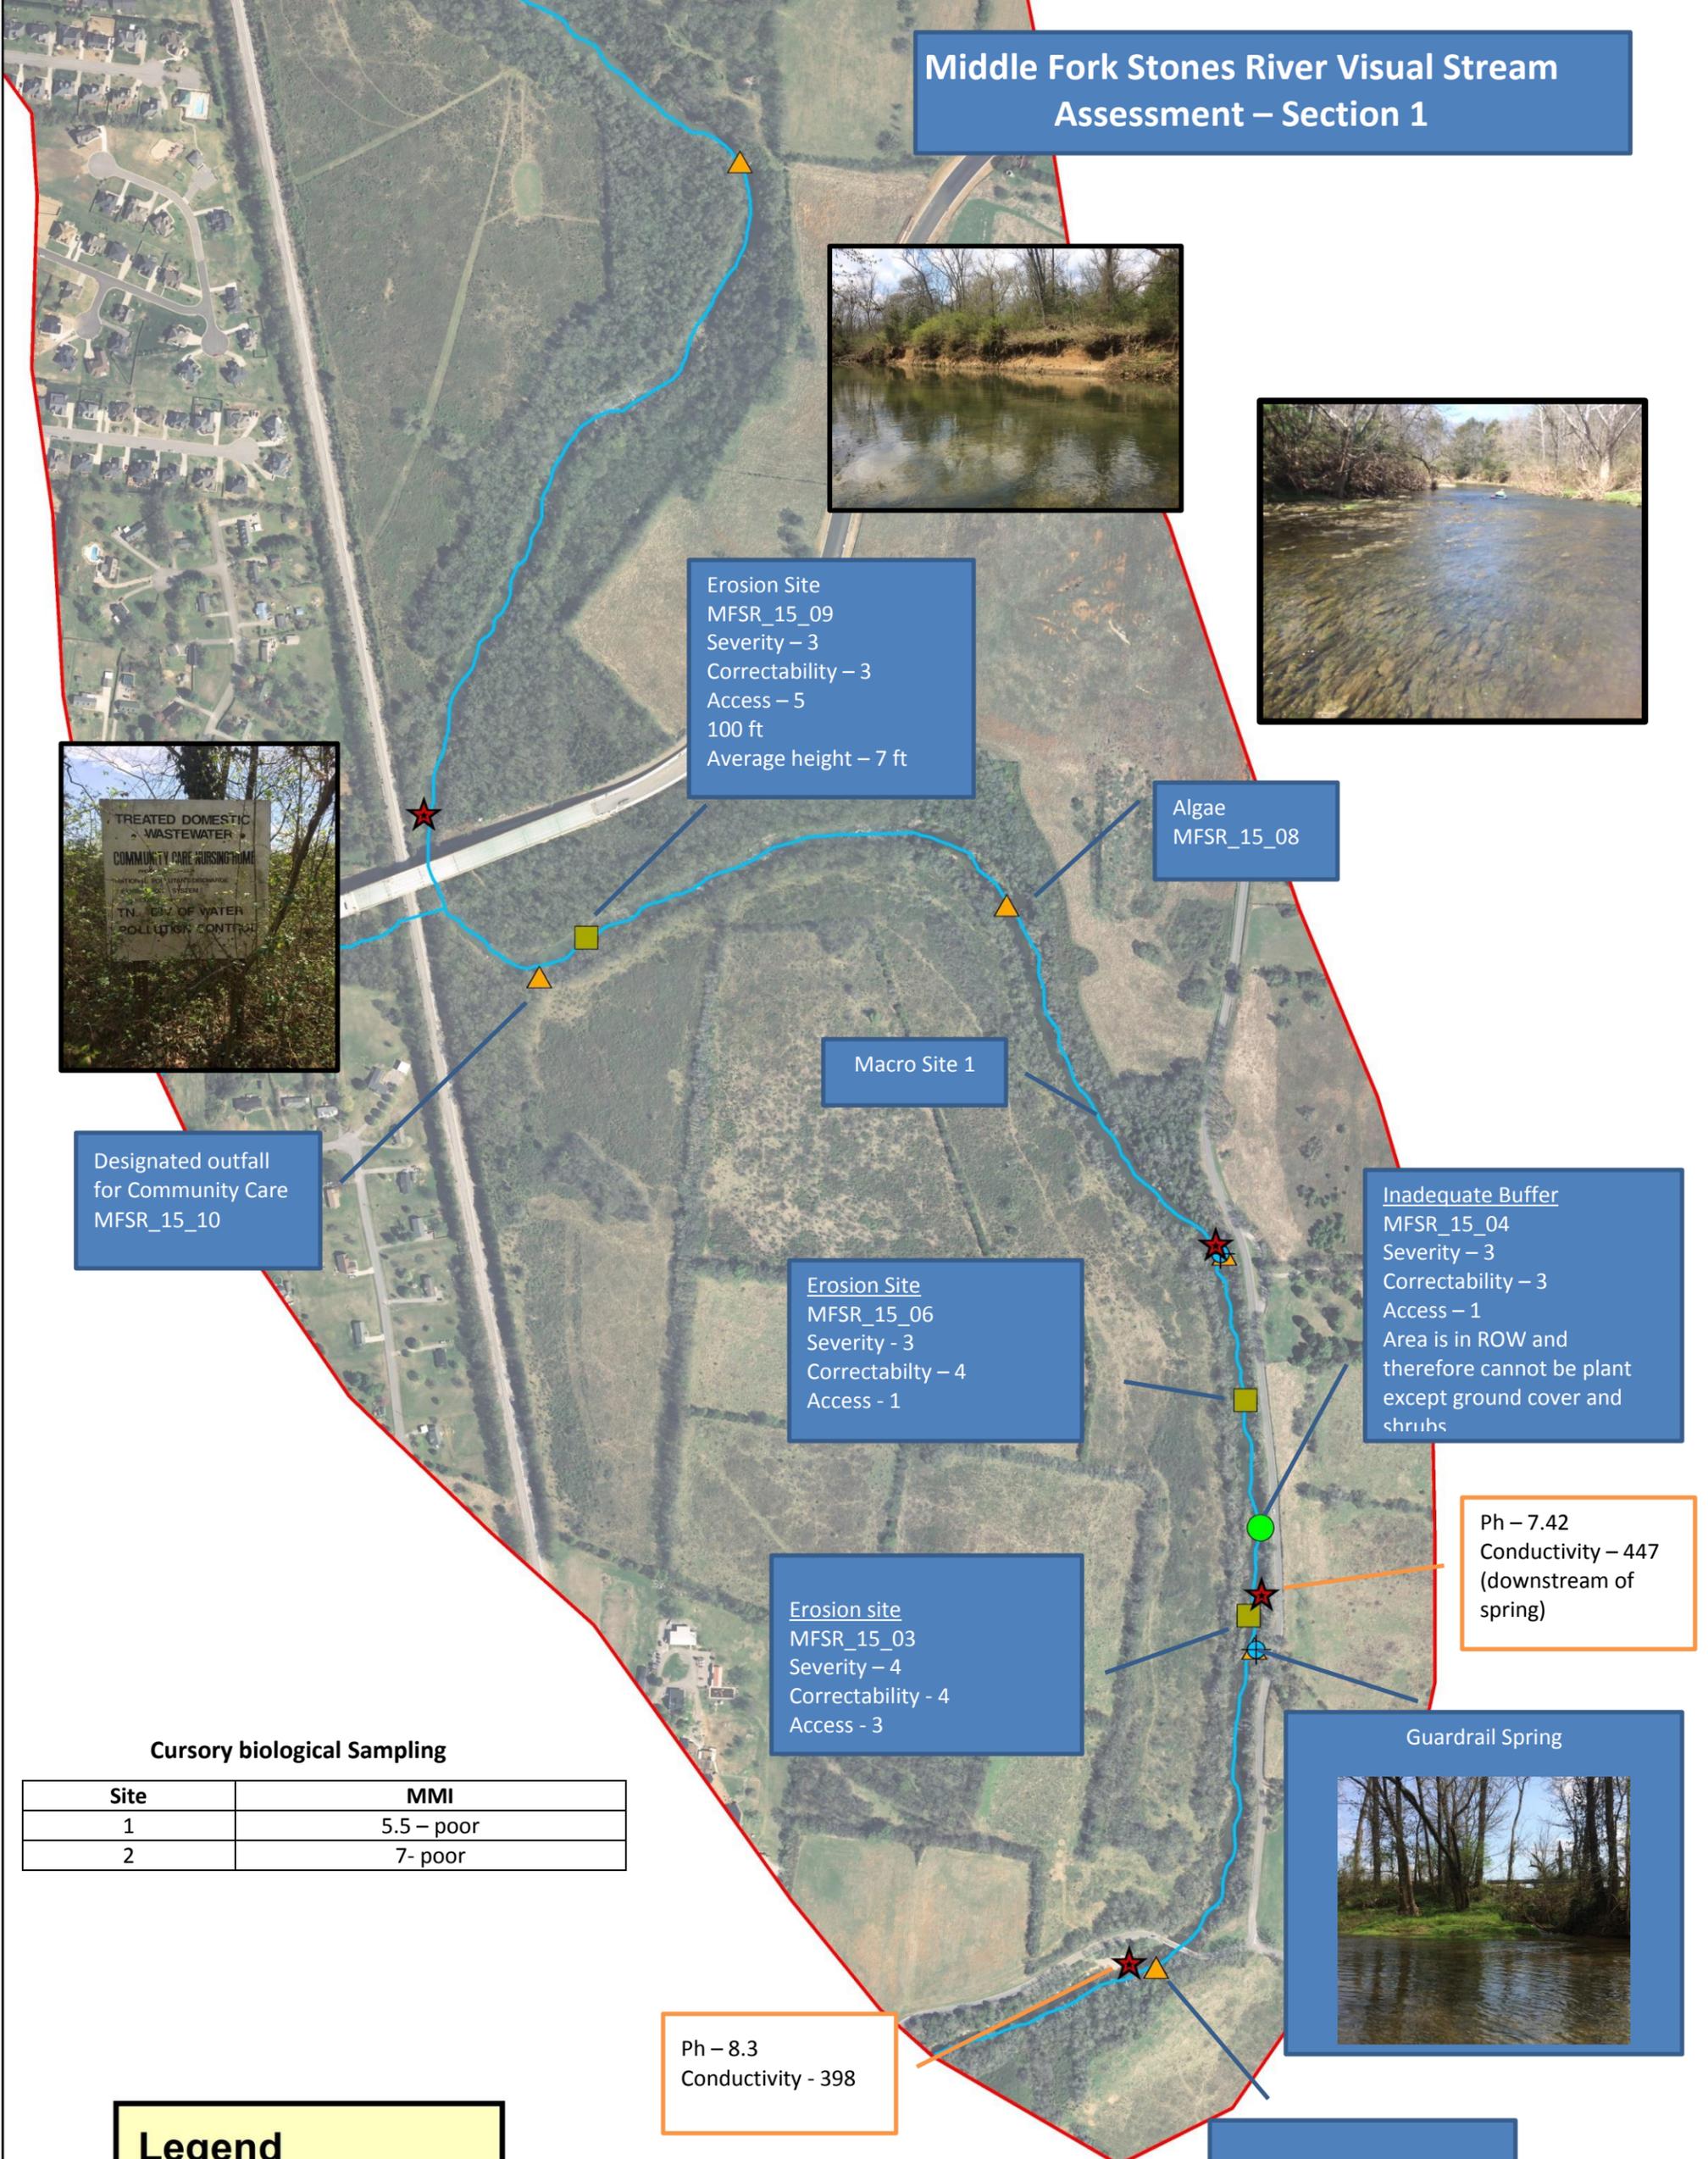
Middle Fork Stones River Visual Stream Assessment – Section 1

Erosion Site
MFSR_15_09
Severity – 3
Correctability – 3
Access – 5
100 ft
Average height – 7 ft

Algae
MFSR_15_08

Designated outfall
for Community Care
MFSR_15_10

Inadequate Buffer
MFSR_15_04
Severity – 3
Correctability – 3
Access – 1
Area is in ROW and
therefore cannot be plant
except ground cover and
shrubs

Erosion Site
MFSR_15_06
Severity - 3
Correctability – 4
Access - 1

Erosion site
MFSR_15_03
Severity – 4
Correctability - 4
Access - 3

MFSR_15_01
Meander or spring
(stonework present)

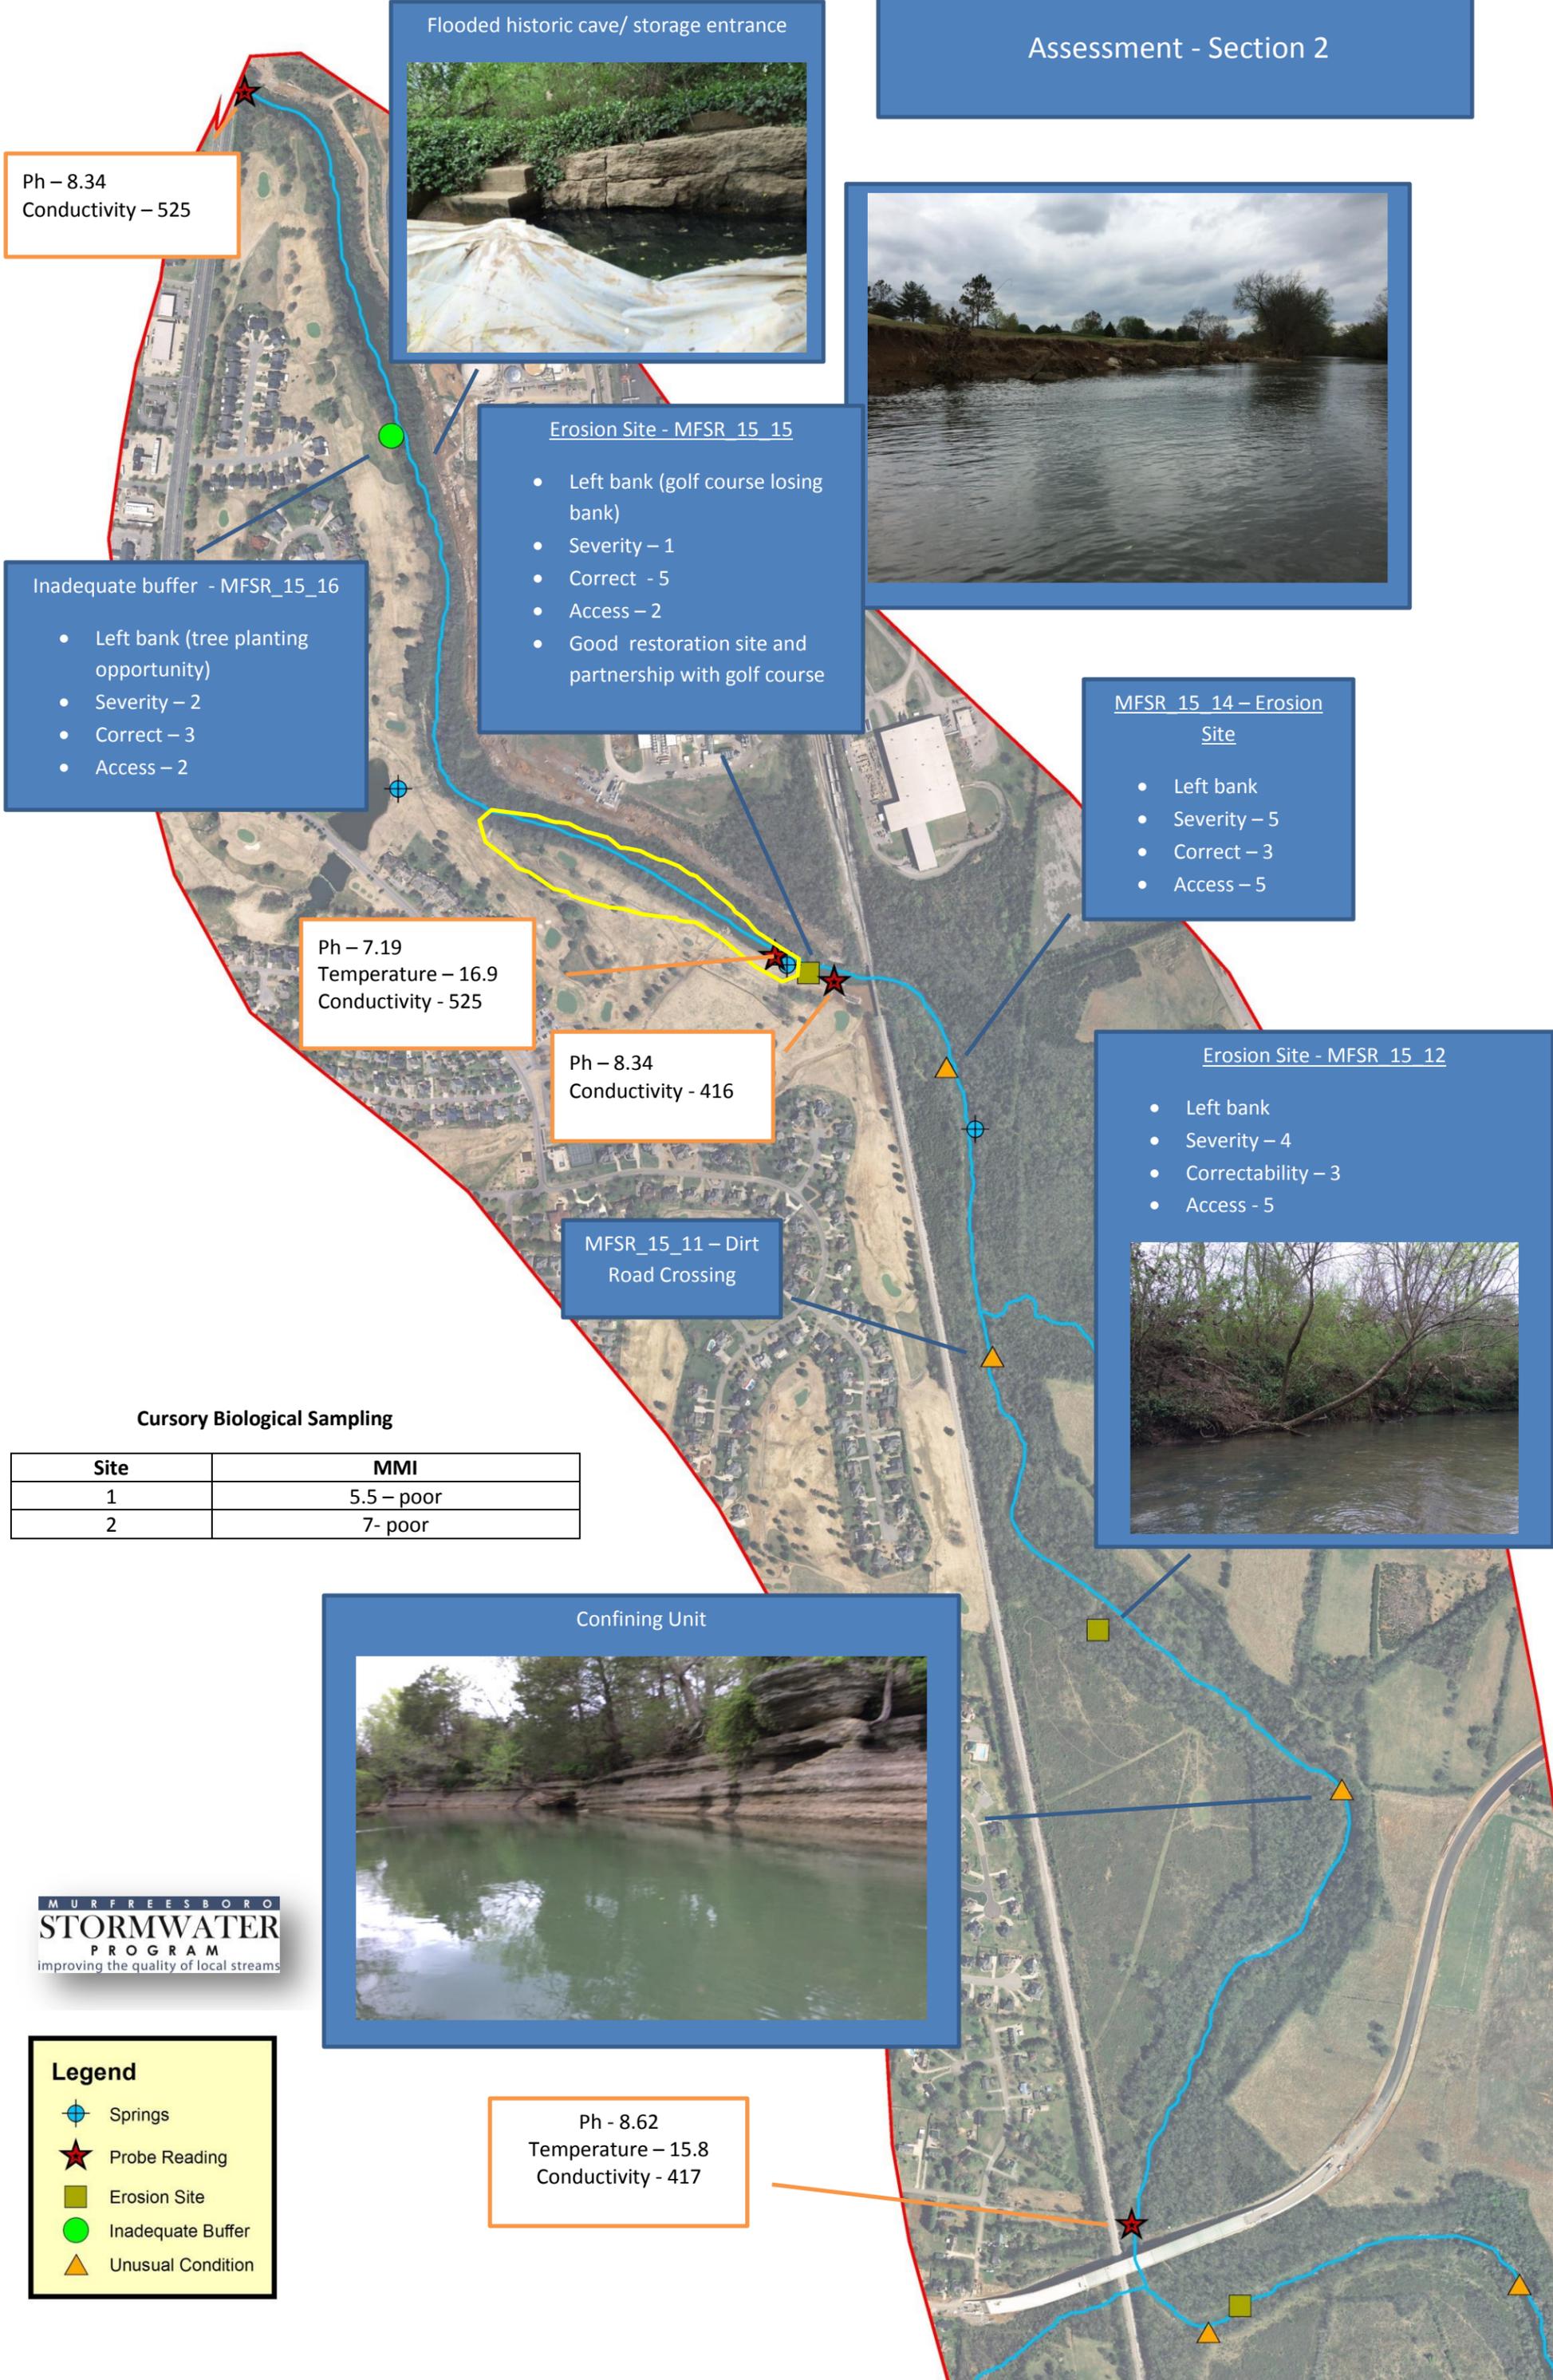
Middle Fork Stones River Assessment - Section 2

Erosion Site - MFSR_15_15

- Left bank (golf course losing bank)
- Severity - 1
- Correct - 5
- Access - 2
- Good restoration site and partnership with golf course

Inadequate buffer - MFSR_15_16

- Left bank (tree planting opportunity)
- Severity - 2
- Correct - 3
- Access - 2

MFSR_15_14 - Erosion Site

- Left bank
- Severity - 5
- Correct - 3
- Access - 5

MFSR_15_11 - Dirt Road Crossing

Erosion Site - MFSR_15_12

- Left bank
- Severity - 4
- Correctability - 3
- Access - 5
