**GROUND WATER (DYE) TRACING IN MURFREESBORO FOR PLANNING BEST
MANAGEMENT PRACTICES FOR STORMWATER RUNOFF, PREDICTING
SINKHOLE FLOODING PROBLEMS, AND TO AID IN CHEMICAL SPILL
RESPONSE**

The City of Murfreesboro

Albert E. Ogden, Ph.D.

May 5th, 2011

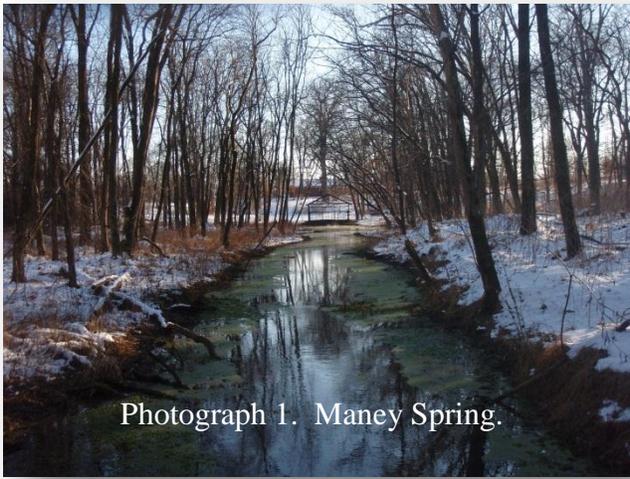
Photograph 1. Maney Spring.

Maney Spring is located on the property of the historic Oakland Mansion (Figure 1 and

Photograph 1). The spring forms the beginning of Sinking Creek. The author previously performed three traces to this spring so it was not originally intended to be included in the present study. One pound of sulphorhodamine B was injected into a sinkhole located within the College Grove Apartments complex on February 1st, 2011, and was expected to be detected at Bear Spring or Lufkin Spring. It was not, so the trace was repeated on March 18th with two pound of fluorescein (Photograph 2), and this time Maney Spring was monitored. The dye was detected there. With these four traces, it is possible to delineate with significant accuracy the entire watershed that provides recharge to the spring. This includes much of the MTSU campus, Evergreen Cemetery by the former

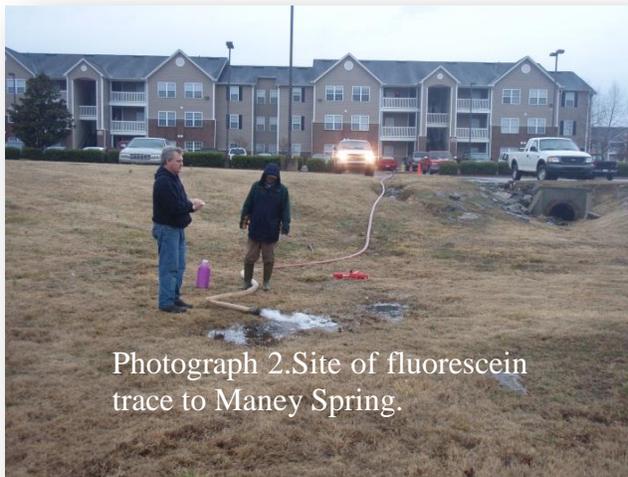
Photograph 2. Site of fluorescein trace to Maney Spring.

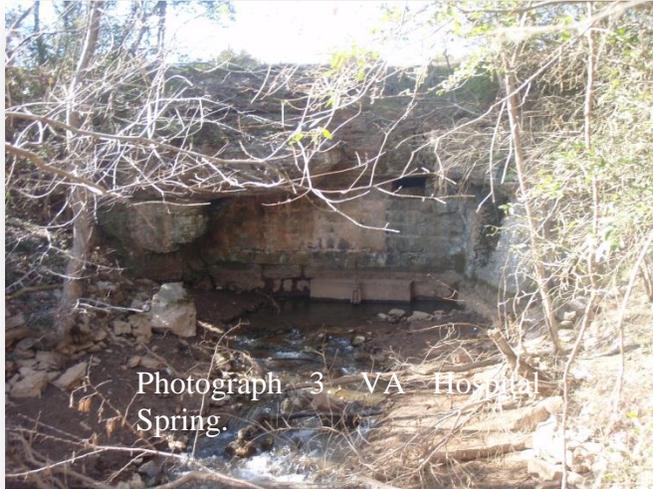
Photograph 3 VA Hospital Spring.

The VA Hospital Spring is the source of the water for the lake on the hospital property (Figure 2

and Photograph 3). The spring emerges from Black Cat Cave which has been mapped by members of the Tennessee Cave Survey. The cave was used as a “speakeasy” bar during Prohibition. Two previous traces were conducted by the author to this spring for the Rutherford County Board of Education, so it was not intended to be included in the present study. On February 1st, 2011, 1½ pounds of sulphorhodamine B were

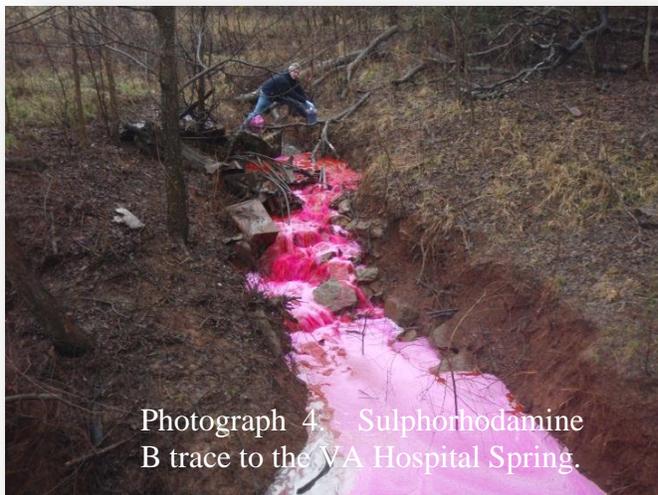
Photograph 4 Sulphorhodamine B trace to the VA Hospital Spring.

injected into a sinkhole (Photograph 4) that receives most of the storm water runoff from the State Farm Insurance headquarters located at the corner of DeJarnette Lane and Memorial Blvd. One and a half pounds of fluorescein were injected shortly after that into a sinkhole (Photograph

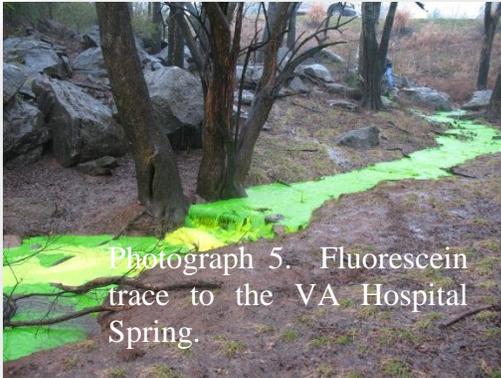
Photograph 5. Fluorescein trace to the VA Hospital Spring.

5) located on the north side of DeJarnette near the northern end of the Murfreesboro Airport runway. Ayers Spring (Photograph 6) or Lufkin Spring (Photograph 7) was expected to receive the dyes. The laboratory results proved negative so the traces were repeated on February 24th, and the VA Hospital Spring was monitored. This time, both traces were positive. A third trace was conducted on the 24th using one

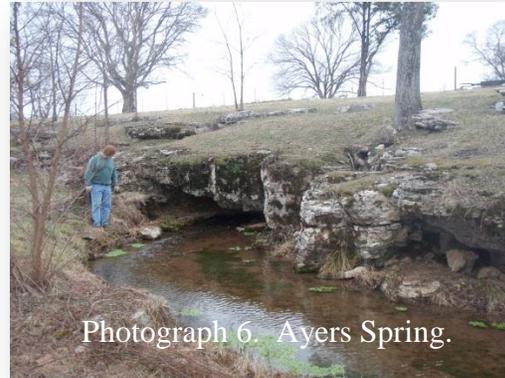
Photograph 6. Ayers Spring.

Lufkin Spring (Figure 5) forms the head of Bear Branch during the dry season. Nearby Ayers Spring (Figure 5) forms the head of Dry Branch during dry conditions. The flow of these two springs combine and within a short distance enters the East Fork of the Stones River just above the city's water intake on Walther Hill dam. Boiling Spring (Figure 4) is commonly the head of Puckett Creek during the dry season. Puckett Creek joins Overall Creek which then flows into the West Fork of the Stones River.

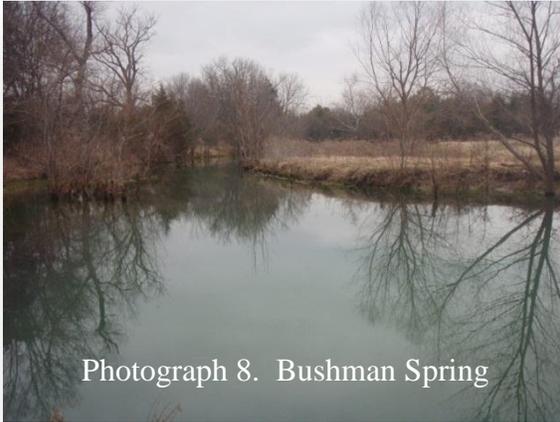
Bushman Springs forms the head of Bushman Creek (Figure 3 and Photograph 8) and is one of the largest springs in the County. Based on many previous dye traces by the author, the spring basin has a large drainage area including portions of Veals Road and Bradyville Pike in

vicinity of Mt. Herman Church. Much of the drainage to sinkholes and karst windows along Flat Rock Road also go to the spring. No traces to the spring had been conducted to the spring from within the Murfreesboro City limits. Therefore, dye was injected into two sinkholes along Halls

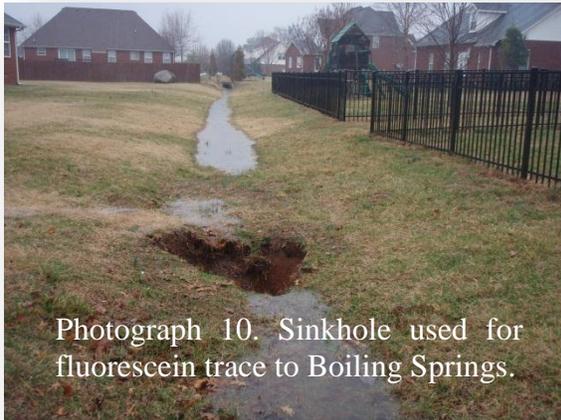
Photograph 10. Sinkhole used for fluorescein trace to Boiling Springs.

24th, one pound of fluorescein was injected into a sinkhole in the Amber Glen subdivision (Photograph 10). Then, one pound of eosine was injected into a sinkhole located immediately east of Salem Cove subdivision. Both of the dyes were detected at Boiling Spring, and no dye was detected at River Rock Spring. Boiling Spring is not believed to have a large drainage basin compared to the other springs previously discussed. Much of the

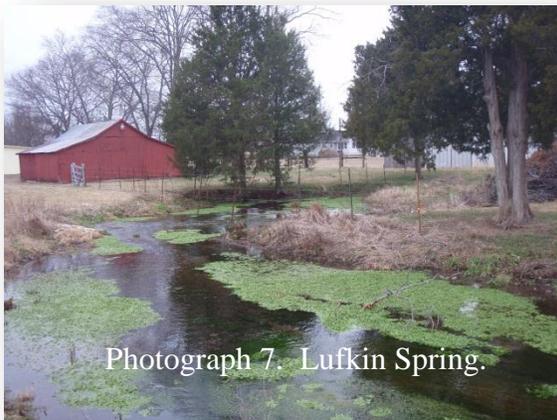
Photograph 7. Lufkin Spring.

Lufkin Spring is a large spring and likely is the resurgence of the surface flow of Bear Branch with sinks and re-appears as springs along its course (Figure 5-Photograph 7). Although tracing from sinking areas along the stream course would have been easy to conduct to Lufkin

Spring, it was felt that sinkholes in the upper reaches of the Bear Branch Basin would provide more valuable information. Therefore, on February 1st, 1½ pounds of eosine were injected into a sinkhole along New Lascassas Road near the Pet Safari Resort. Then, one pound of sulphorhodamine B was injected into the College Grove Apartments sinkhole previously discussed. The following day, 1½ pounds of fluorescein were injected
