Garrison Creek Pollution Reduction Plan

Last updated: 11/25/2014
Re: MS4 Permit, **Section 3.1 Discharges to Water Quality Impaired Waters**
(Including requirements in 5.1, 5.2)

Waterbody I.D. #: TN05130203023_0210
Subwatershed: East Fork Stones River (water shed – 971 acres)

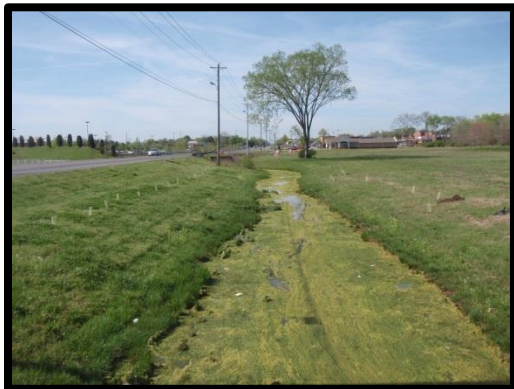
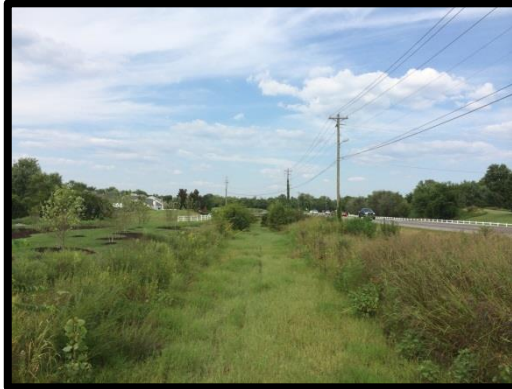
The city of Murfreesboro established a 30 foot no mow zone on either bank adjacent to Garrison Creek from the confluence with Bushman Creek to Rutherford Blvd. Partners supplemented the established riparian zone with volunteer tree plantings of bare root seedlings, live stakes, and larger native vegetation. Vegetative fauna and macro invertebrate populations are being monitored.
