# Upper West Fork Stones River

## Visual Stream Assessment

## Watershed Characterization

Murfreesboro Water and Sewer

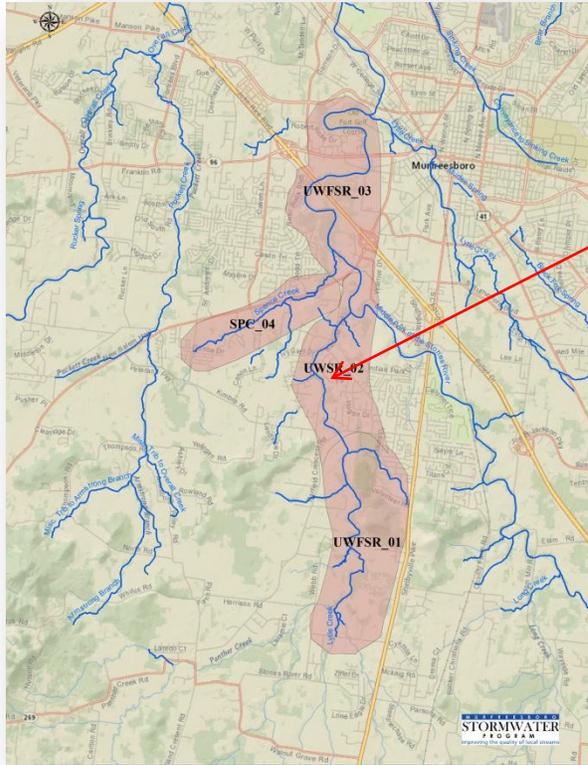
**“UWFSR0202 – Inadequate Buffer”**

“UWFSR02” = Sector, “02” = number of point with sector

**Severity = 1** – “A section of stream with trees on both sides of the stream, but on one side the stream buffer is less than 50 ft wide”

**Correctability = 1** – Small reach on residential property where a no mow zone and trees could be planted easily

**Access = 1** – Easily accessible both by car and foot.

**Priority Score = 3**

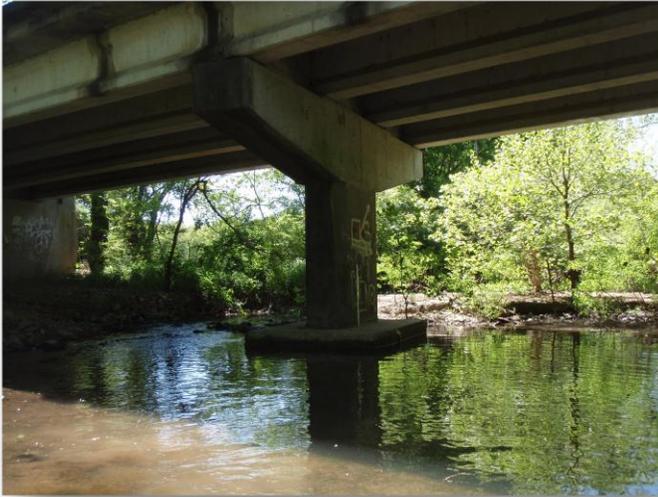
## UW0101 Old Road Crossing

- 4/23/2012
- 86°25'40.618"W,  
35°44'59.148"N
- Josh Upham and Bruce Ross
- Severity = 3
- Correctability = 4
- Accessibility = 2
- Old road crossing with breaches that allow fish passage.

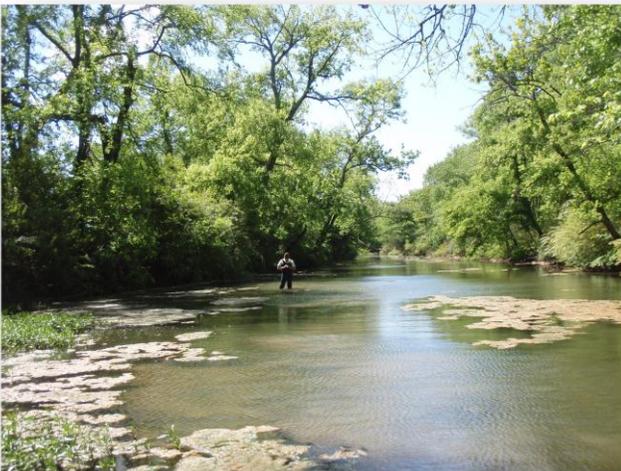
## UW0102 Algae Inundation

- 4/23/2012
- 86°25'35.735"W,  
35°44'59.148"N
- Josh Upham and Bruce Ross
- Large patches of algae.

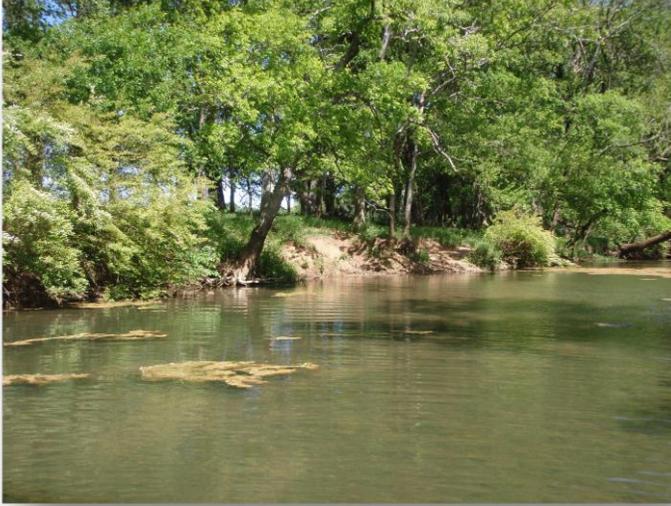
## UW0103 Bank Erosion

- 4/23/2012
- 86°25'33.037"W,  
35°44'59.148"N
- Josh Upham and Bruce Ross
- Severity = 4
- Correctability = 1
- Accessibility = 2
- Left Bank
- Lack of vegetative cover

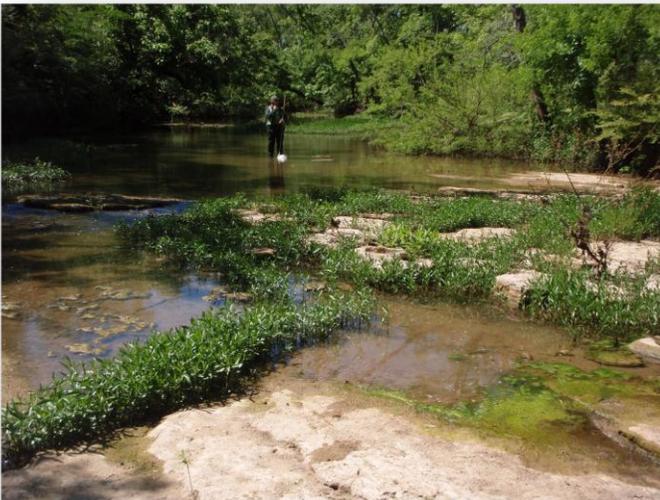
## UW0104 Dipping Strata

- 4/23/2012
- 86°25'29.246"W,  
35°44'57.927"N
- Josh Upham and Bruce Ross
- Possible synclinal axis.

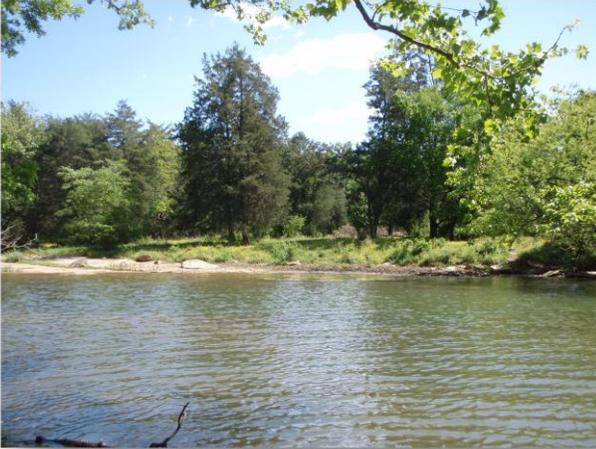
## UW0106 Inadequate Buffer

- 4/23/2012
- 86°25'27.529"W,  
35°44'54.963"N
- Josh Upham and Bruce Ross
- Severity = 2
- Correctability = 2
- Accessibility = 4
- Left Bank
- Lack of vegetative cover,  
possible cattle crossing

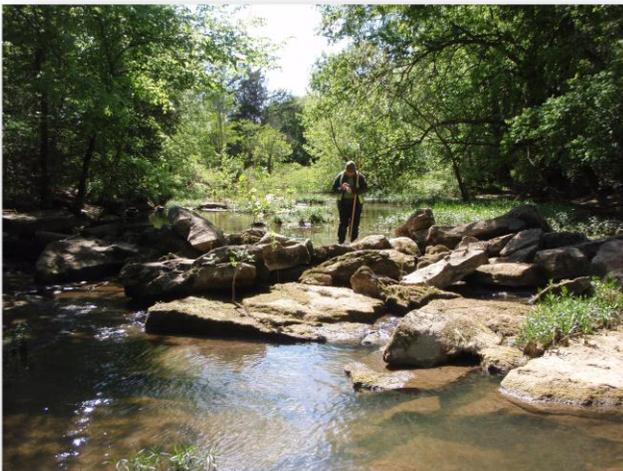
## UW0107 Rock Wall

- 4/23/2012
- 86°25'23.661"W,  
35°44'55.223"N
- Josh Upham and Bruce Ross
- Severity = 3
- Correctability = 4
- Accessibility = 5
- Rock pile across stream

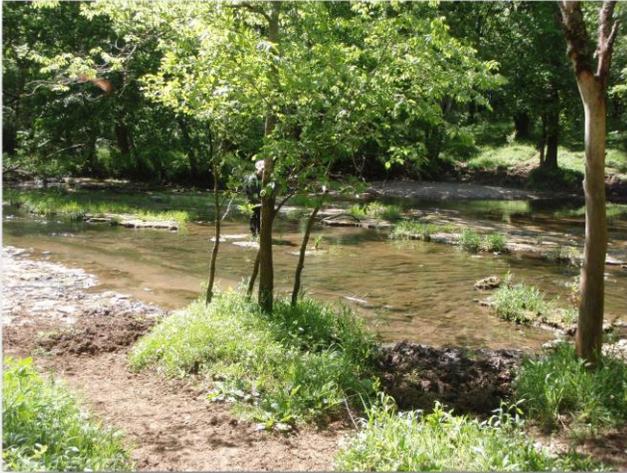
## UW0108 Possible Cattle Crossing

- 4/23/2012
- 86°25'1.414"W,
- 35°46'24.6"N
- Josh Upham and Bruce Ross
- Severity = 5
- Correctability = 1
- Accessibility = 2
- Both banks
- Possible cattle crossing could be corrected with vegetation and ending cattle access.

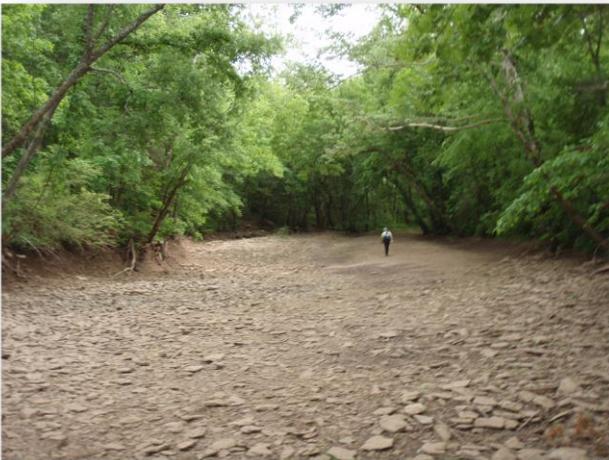
## UW0109 Sinking Segment

- 4/24/2012
- 86°24'58.845"W,  
35°45'56.332"N
- Josh Upham and Bruce Ross
- Severity = NA
- Correctability = NA
- Accessibility = NA
- River sinks completely, relatively dry conditions but plenty of flow upstream. May emerge at spring downstream.

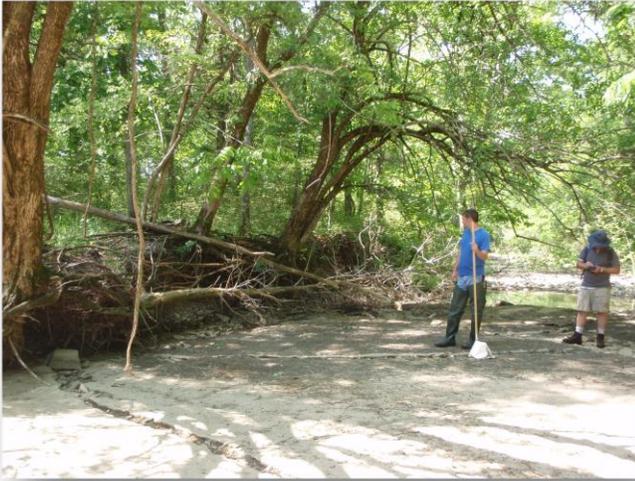
## UW0112 Erosion Site

- 4/24/2012
- 86°25'1.414"W,
- 35°46'22.03"N
- Josh Upham and Bruce Ross
- Severity = 3
- Correctability = 4
- Accessibility = 1
- Left Bank
- Minor erosion in natural meander.

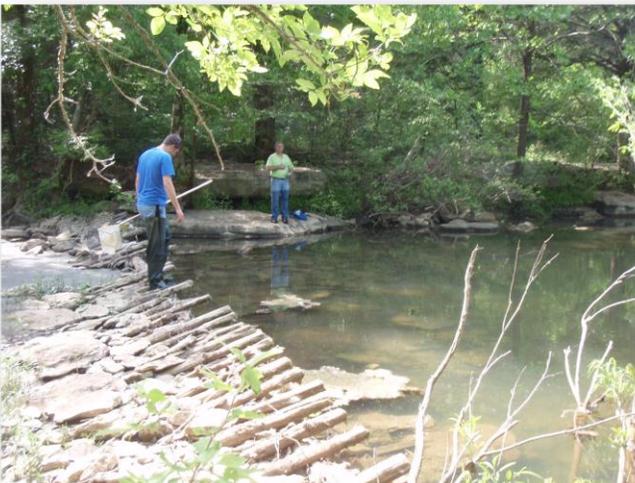
## UW0113 & 14 poles in stream

- 4/24/2012
- 1 - 86°25'5.8"W,  
35°46'28.915"N
- 2 - 86°25'11.497"W  
35°46'37.331"N
- Josh Upham and Bruce Ross
- Severity = 4
- Correctability = 2
- Accessibility = 3
- Poles in stream may be remnants of old fence. Should be relatively easy to remove.

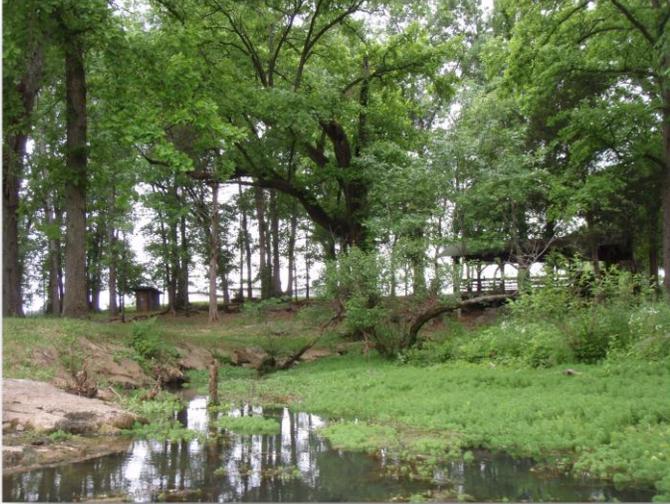
## UW0115 Large Spring

- 4/24/2012
- 86°25'15.758"W,
- 35°46'51.101"N
- Josh Upham and Bruce Ross
- Severity = NA
- Correctability = NA
- Accessibility = NA
- Large spring may be the resurgence of the WFSR

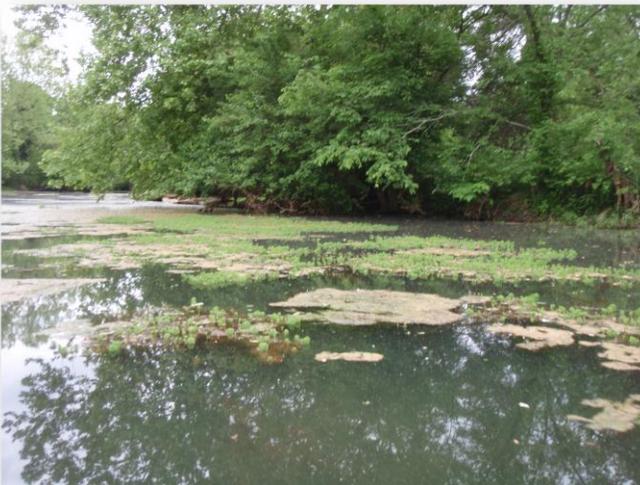
## UW0116 Parrot Feather

- 4/24/2012
- 86°25'11.575"W  
35°46'56.133"N
- Josh Upham and Bruce Ross
- Severity = NA
- Correctability = NA
- Accessibility = NA
- Parrot Feather covering much of the river.

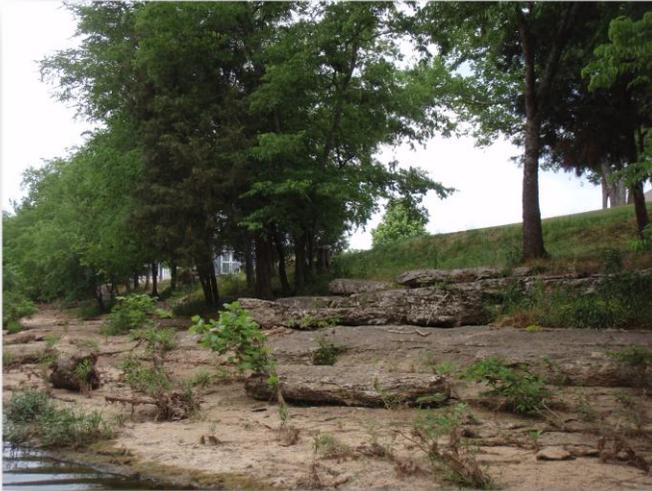
## UW0202 INADEQUATE BUFFER

- 5/1/2012
- 86°25'28.845"W,
- 35°47'24.504"N
- Josh Upham and Bruce Ross
- Severity = 5
- Correctability = 1
- Accessibility = 1
- Mowing to the bank on the right side. Need to establish no mow zones.

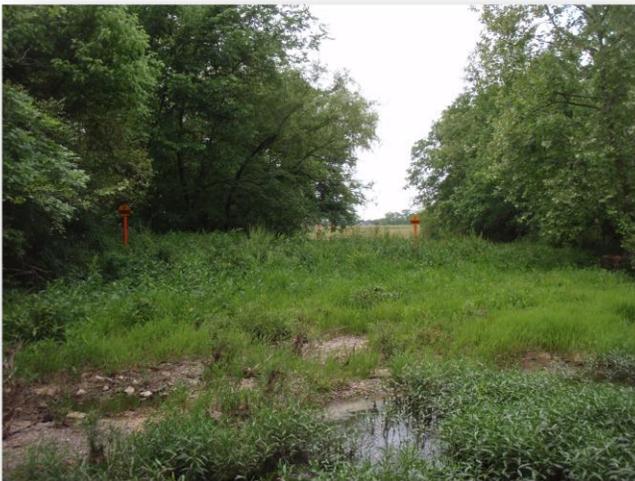
## UW0203 Pipeline

- 5/1/2012
- 86°25'30.695"W  
35°47'28.77"N
- Josh Upham and Bruce Ross
- Severity = NA
- Correctability = NA
- Accessibility = NA

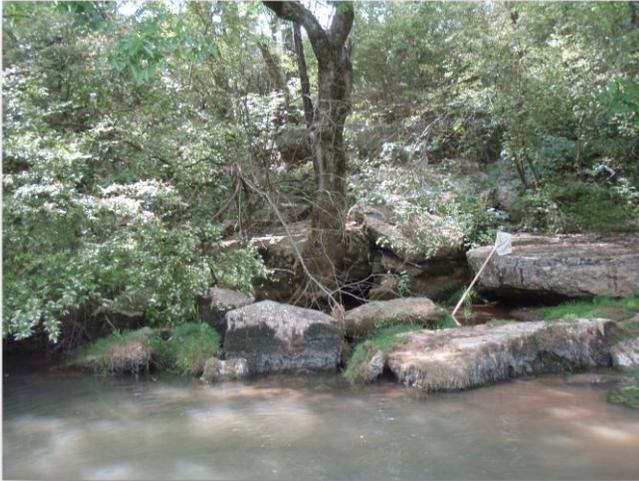
## UW0206 Large Spring

- 5/1/2012
- 86°25'43.269"W,
- 35°48'5.467"N
- Josh Upham and Bruce Ross
- Severity = NA
- Correctability = NA
- Accessibilty = NA
- Large spring despite low flow in river. Possible large recharge basin.

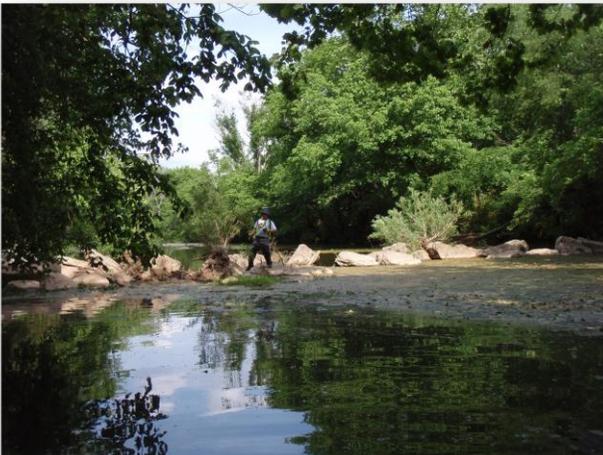
## UW0207 Rock line

- 5/1/2012
- 86°25'36.309"W
- 35°48'15.104"N
- Josh Upham and Bruce Ross
- Severity = 3
- Correctability = 4
- Accessibility = 4
- Line of boulders crossing stream.

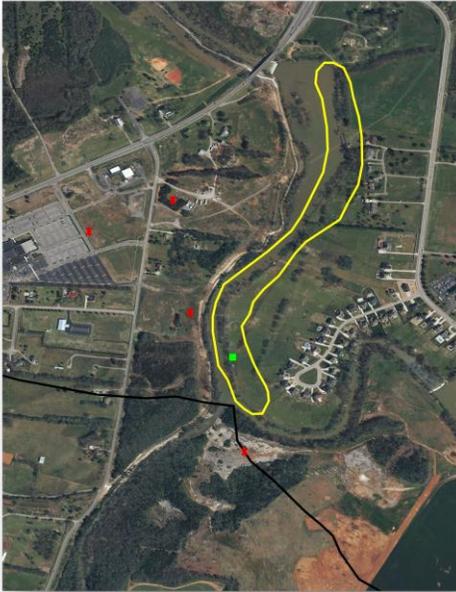
## UW0209 Inadequate Buffer

- 5/4/2012
- 86°25'7.456"W,
- 35°48'49.69"N
- Josh Upham and Bruce Ross
- Severity = 4
- Correctability = 2
- Accessibility = 1
- Several properties along the right bank on Sterling Lake are mowing to the bank. Good place to establish now mow zone with view sheds.

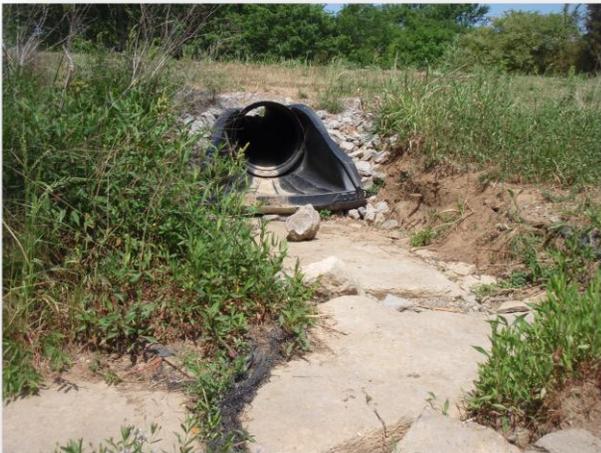
## UW0210 Pipe Outfall

- 5/4/2012
- 86°25'8.206"W  
35°48'57.292"N
- Josh Upham and Bruce Ross
- Severity = NA
- Correctability = NA
- Accessibility = NA
- Pipe outfall.

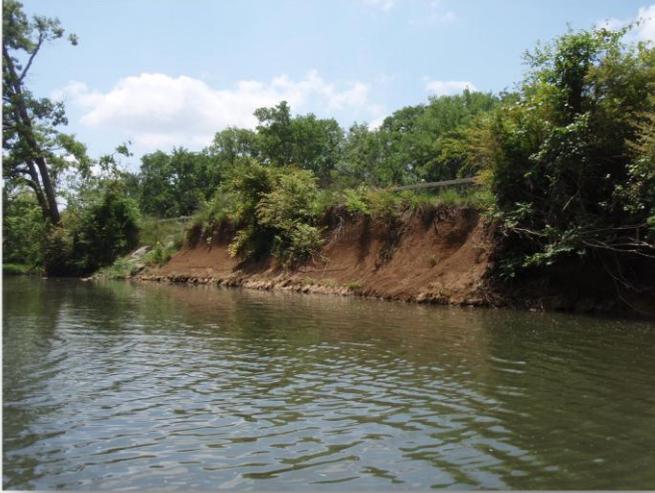
### UW0301 Erosion Site

- 5/4/2012
- 86°25'18.995"W,
- 35°49'29.677"N
- Josh Upham and Bruce Ross
- Severity = 1
- Correctability = 4
- Accessibilty = 2
- Large erosion site on left bank that continues an estimate 2,500 ft. Stabilization project being planned

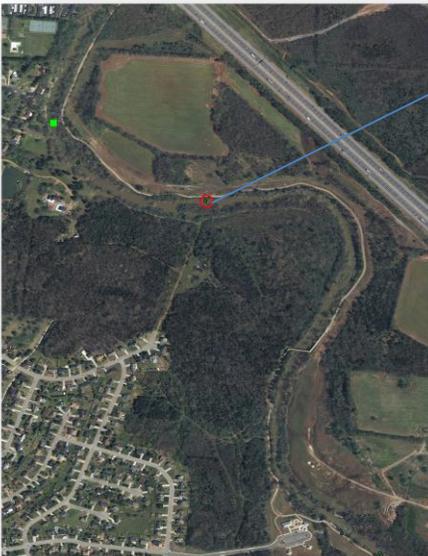
### UW0302 Erosion Site

- 5/10/2012
- 86°25'36.128"W
- 35°50'4.096"N
- Josh Upham and Bruce Ross
- Severity = 2
- Correctability = 3
- Accessibility = 5
- Small erosion site on the right bank below greenway trail.

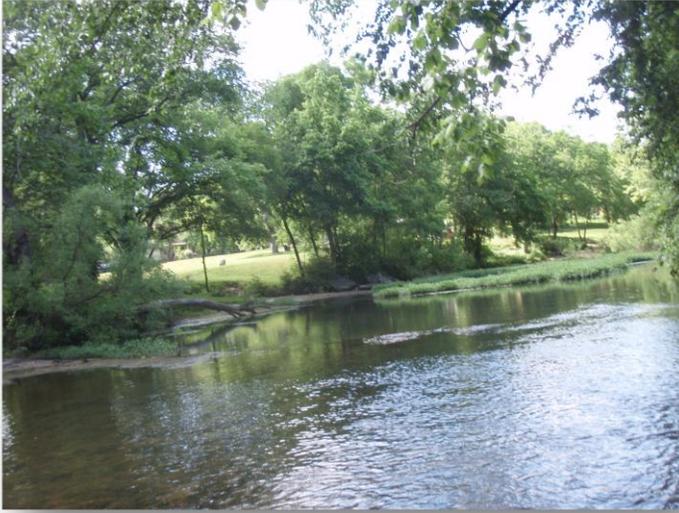
## UW0304 Inadequate Buffer

- 5/10/2012
- 86°25'50.94"W,
- 35°50'11.493"N
- Josh Upham and Bruce Ross
- Severity = 5
- Correctability = 1
- Accessibilty = 1
- Area being mowed to the bank of about 300 ft with sporadic trees,

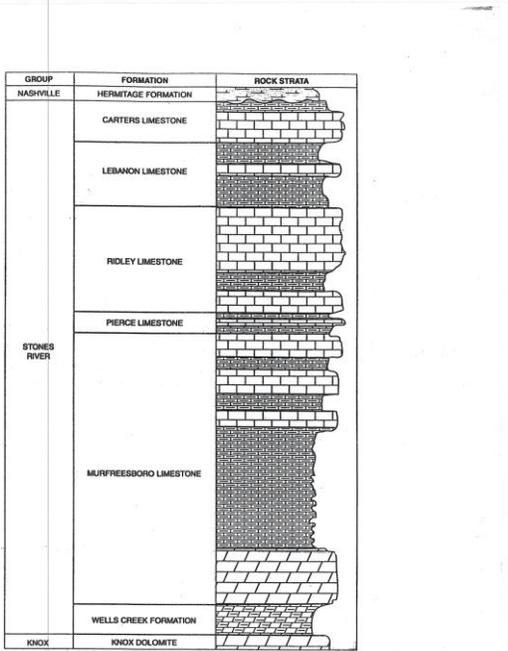
Figure 2. Stratigraphic column of the study area (from Farmer and Hollyday, 1999).

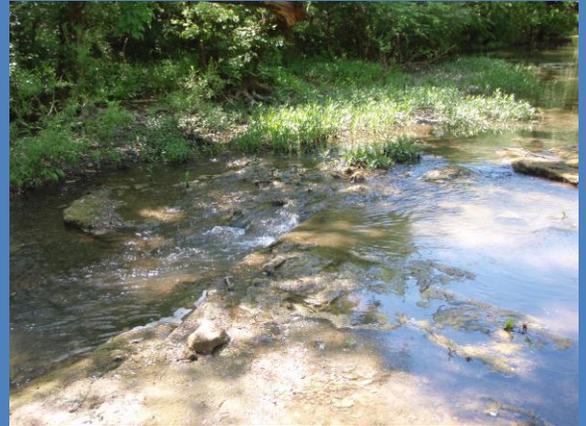
Macro Site 101

<u>Macrobenthos</u>	<u>Abundance</u>
Gastropoda	Dominant 50 +
Riffle Beetle	Dominant 50 +
Water penny	Dominant 50 +
Halgramite	Common 3-9

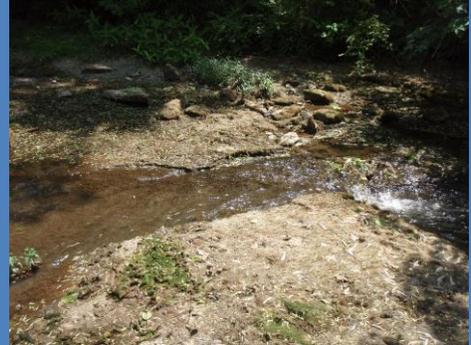
### Macro Site 201

Gastropoda	Abundant 10 +
Coleoptera	Abundant 10 +
Ephemeroptera	Abundant 10 +
Trichoptera	Abundant 10 +
Plecoptera	Abundant 10 +

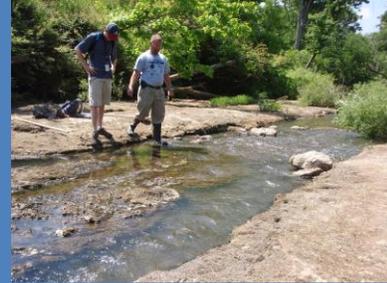
### Macro Site 301

<u>Macrobenthos</u>	<u>Abundance</u>
Ephemeroptera	Abundant 10 +
Trichoptera	Abundant 10 +
Coleoptera	Abundant 10 +
Gastropoda	Abundant 10 +

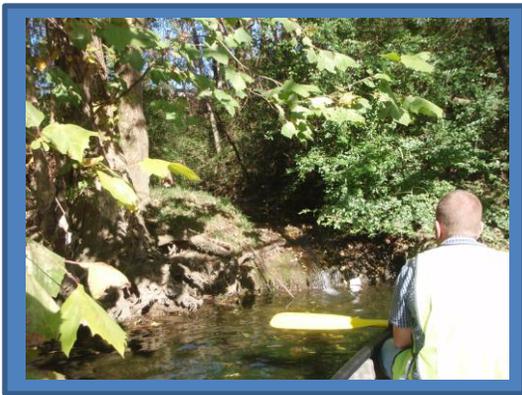
2. Large culvert located approximately 150 ft. off the right bank of the West Fork Stones River near the intersection of NW Broad St and Northfield Blvd. Culvert is thought to be a moderate size spring that has been pipe in conjunction with stormwater infrastructure as indicated on old maps and photography but not confirmed.

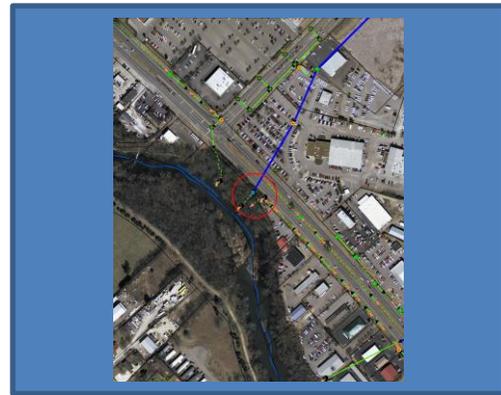
3. Large rip rap ditch and culvert on left bank of the West Fork Stones River near intersection of W. College St. and Hope Way. Flow sampled to have .6 mg/l fluoride and near old dye traces. The flow could be groundwater or loss of water at a nearby lake used for storing re purified water. This area will be continued to be monitored.
