## *Lytle Creek Pollution Reduction Plan*

Last updated: 7/1/2015 - Upham  
Re: MS4 Permit, **Section 3.1 Discharges to Water Quality Impaired Waters**  
(Including requirements in 5.1, 5.2)

Waterbody I.D. #: TN05130203022\_1000  
Subwatershed: Lytle Creek (water shed – 1,553 acres)

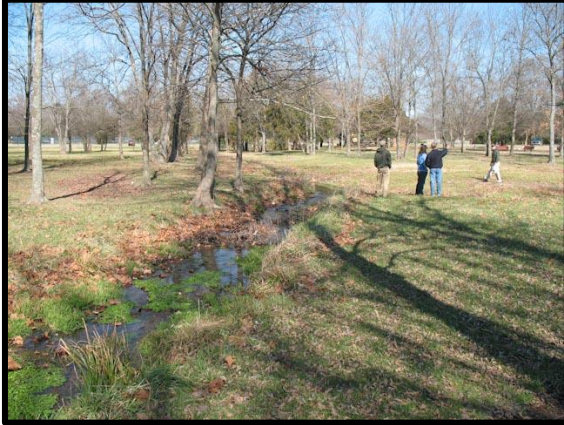
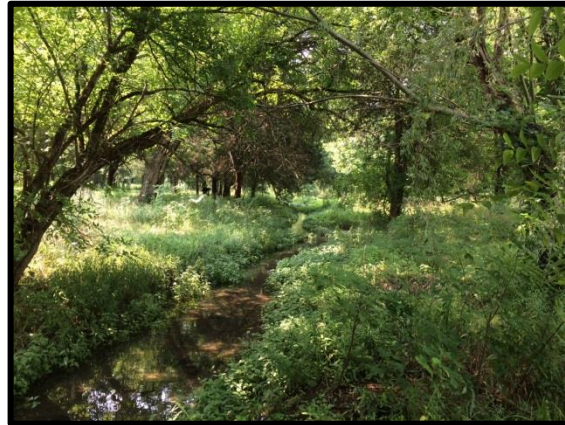
The City of Murfreesboro Parks and Recreation Department partnered with the Stormwater program to renovate Old Fort Park in 2010. The park now serves as a demonstration site for accepted stormwater controls where these controls treat stormwater before it enters Spring Branch and Lytle Creek. Prior to the renovation Spring Branch had little riparian buffer and some eroding bank. A wide buffer was established in the project in which native vegetation was featured. The Stormwater Program summoned a professional habitat assessment and biological analysis before and after the project and plans to continue to monitor habitat to gage the effectiveness of such BMP’s.

<b>Control/ Activity</b>	<b>Quantity</b>	<b>Monitoring</b>
Riparian buffer restoration	2,756 linear feet of riparian zone reestablished with natives grasses, trees, and shrubs	Benthic macro (before and after results ongoing and on file)
Porous Pavement/Pavers	3,971 square feet	--
SRNB Public Lands Day – invasive plant removal and clean – up	Bi-annually	Progress checks
Bio-retention	3,392 sq ft	
Education Brochure	--	--
