Middle Fork Stones River - Visual Stream Assessment

March/ April 2015 (County Farm – S Church St – 3.52 miles)

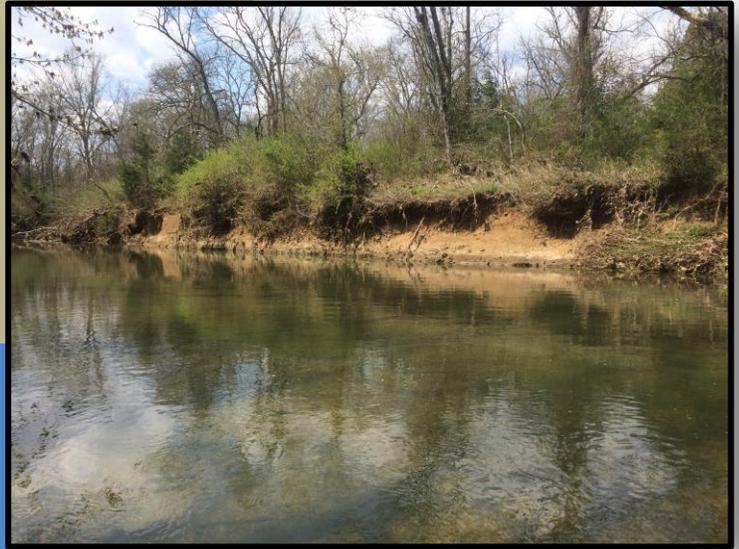
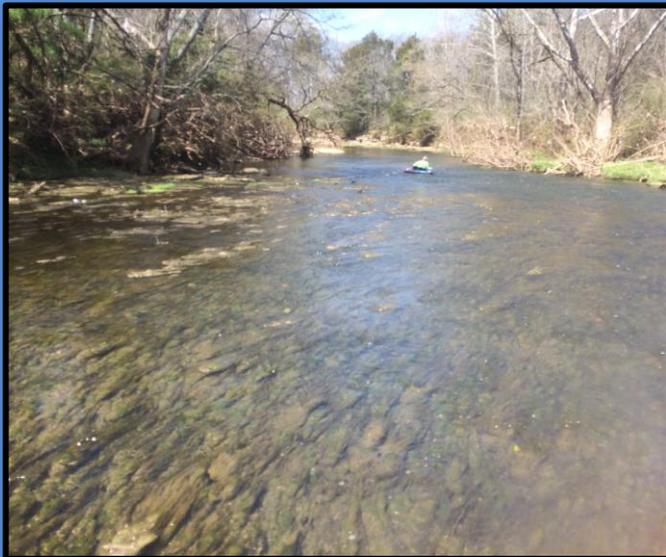
Top Problems

1. Erosion – 970 Ft
2. Invasive Plants in the riparian zone
3. Inadequate buffer – 1,386 Ft
4. Algae

Top Corrective Actions

1. Indian Hills Golf Course – Bank Restoration
(long segment of 3 feet high eroding banks in need of vegetation and stabilization)
2. Locate source of nutrients
(likely agriculture access to the stream directly and via sinkholes)

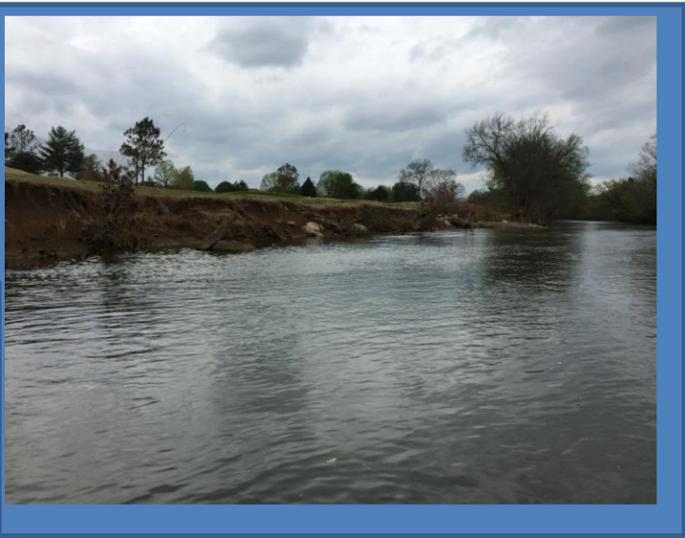
Inadequate buffer - MFSR_15_16

- Left bank (tree planting opportunity)
- Severity - 2
- Correct - 3
- Access - 2

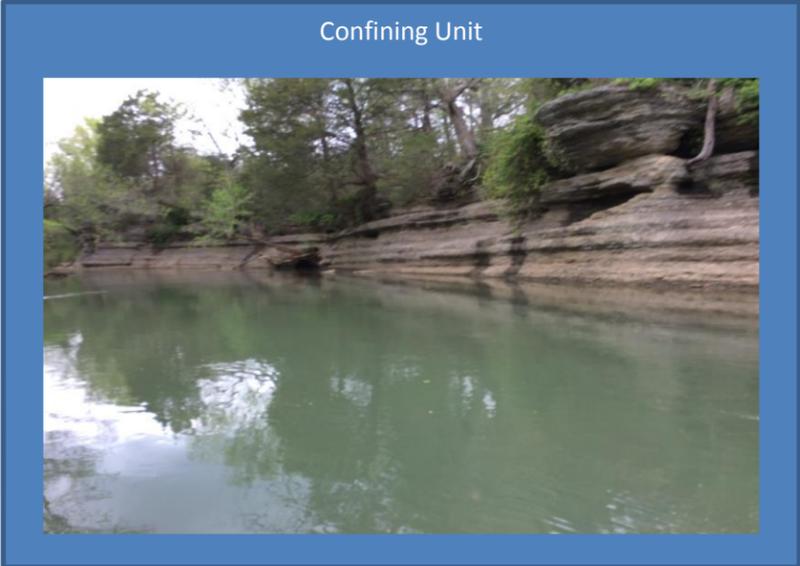
Ph - 8.62
Temperature - 15.8
Conductivity - 417
