Sinking Creek Pollution Reduction Plan

Last updated: 12/4/2014
Re: MS4 Permit, **Section 3.1 Discharges to Water Quality Impaired Waters**
(Including requirements in 5.1, 5.2)

Waterbody I.D. #: TN05130203018_0100
Subwatershed: West Fork Stones River (water shed – 971 acres)

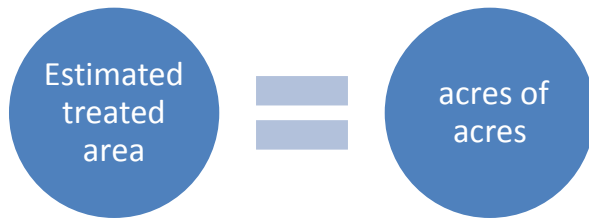
- **PCR Controls**

Control Type	Quantity	Annual change	Estimated Total Removal (model)
Ponds		--	
Weirs		--	
Filter Strip		--	
Infiltration trench		--	
Porous Pavement	6,310 sq ft	--	
Bioretention	33,085 sq ft	--	
Sewer line rehab

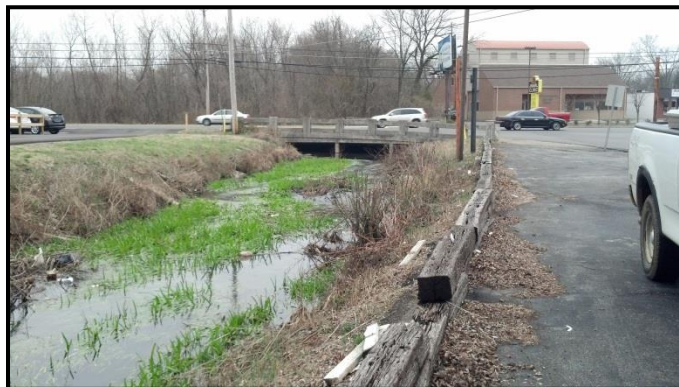
Bank Restoration

Segments of Sinking Creek between Memorial Blvd and Northfield Blvd suffer from moderate bank erosion as noted in the 2014 visual stream assessment. The two separate segments total 418 ft.
